## Technical Annexes - Areas for Action

### Section B: Dealing with condensation, dampness and mould

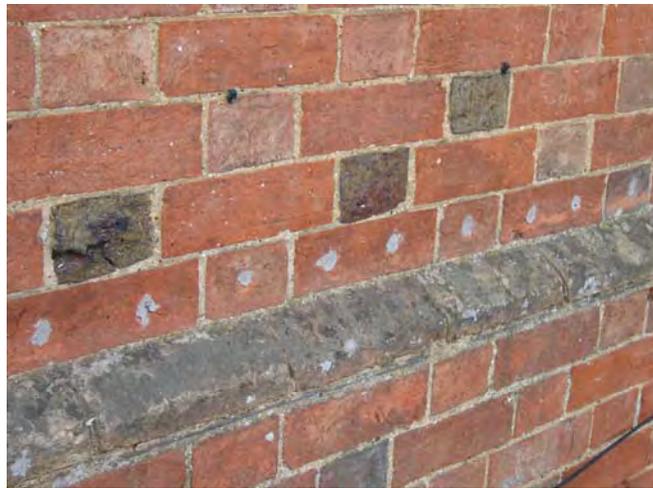
*A brick wall that has had an injected damp proof course installed  
(Picture courtesy of Peter Rickaby)*

If the dpc is defective, it is usually necessary to cut out and replace the defective portion. Where a dpc is absent, the usual solution is to inject a new damp proof course into the existing wall. Holes are drilled at regular intervals around the perimeter of the building, just above external ground level, and a chemical is injected under pressure. The chemical is absorbed into the masonry and forms an effective barrier to the passage of moisture.

Injected dpcs must be installed by specialist contractors, who usually supply a guarantee. Prior to installation, it is necessary to remove any internal plaster finishes from all affected walls up to one metre above the internal ground floor level. Once the dpc has been injected, you can replace the plaster with new, waterproof plaster and replace or make good any skirtings and other finishes.

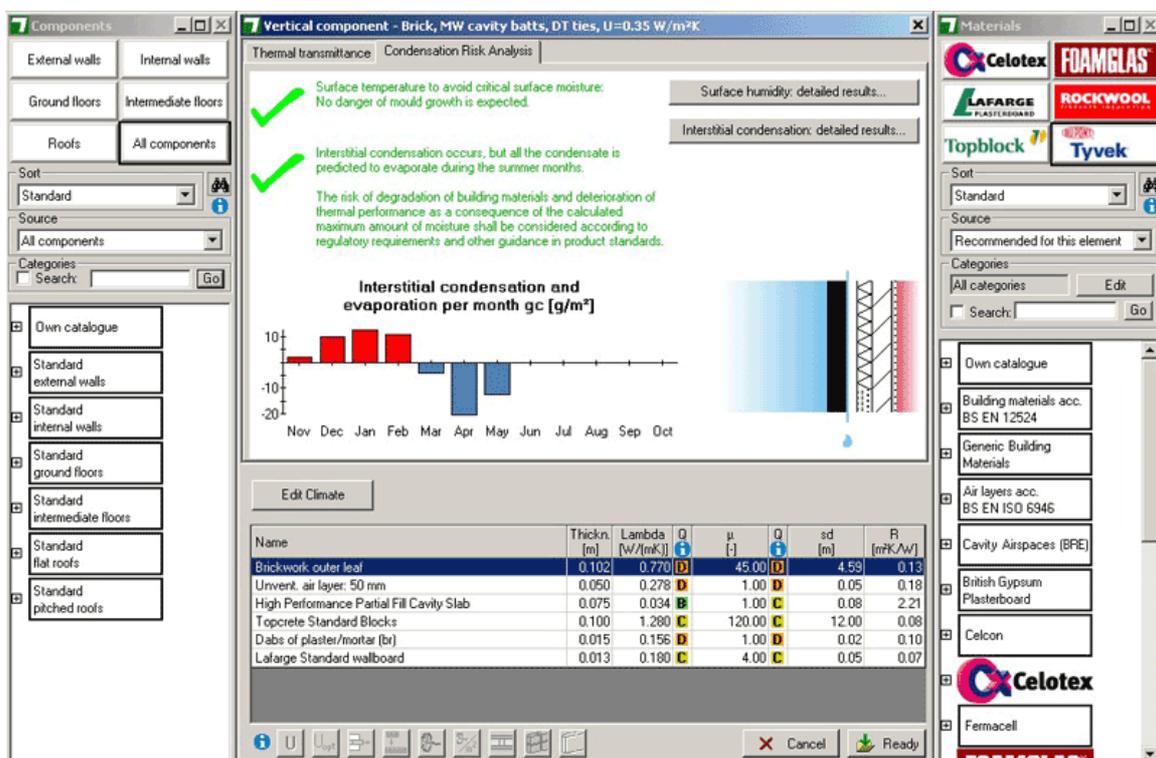
The illustrations below from the BuildDesk U software demonstrates the risk analysis for a partial fill cavity wall construction.

The risk of interstitial condensation should be checked when new build or refurbishment projects are specified. Many software products for calculating the U-values of buildings can also check the risk of interstitial condensation.

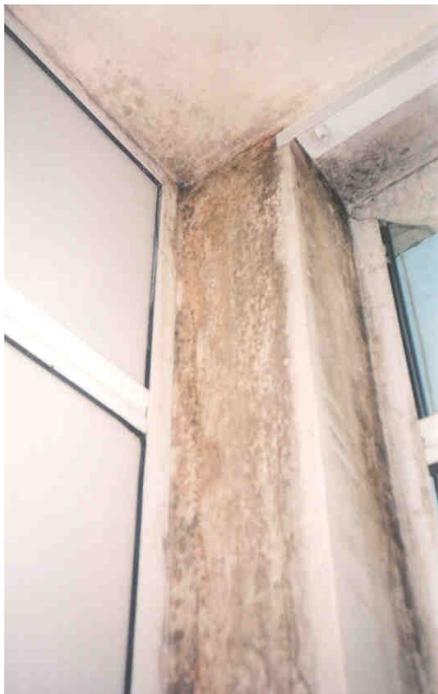
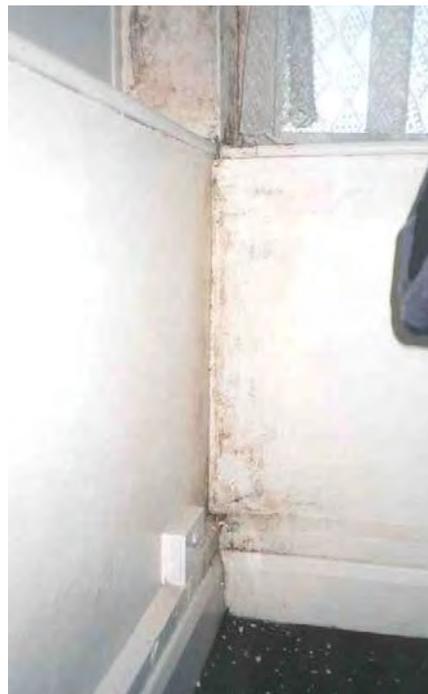
*Dampness and mould staining due to condensation arising from thermal bridging in a building where the structural concrete frame bridges the wall insulation*

You will recognise surface condensation due to thermal bridging because the pattern of staining or mould growth reveals the underlying thermal bridge. Typically, the condensation and mould growth are confined to corners. However, if the staining and mould growth are not dealt with, they will spread, making the thermal bridge more difficult to locate.

Eliminating this type of surface condensation involves eliminating the thermal bridge. You can achieve this most easily by installing insulated dry lining within the home. This raises the internal surface temperature adjacent to the thermal bridge and prevents condensation occurring.

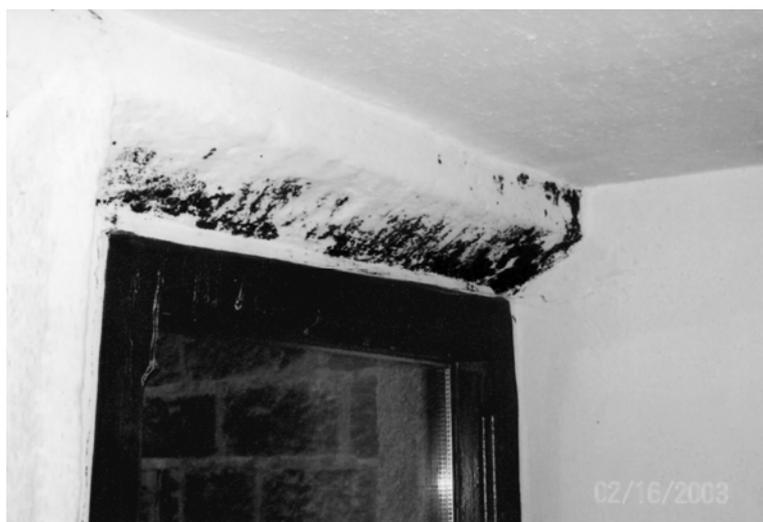
*Dampness and mould staining due to a combination of surface condensation and thermal bridging in an under-heated dwelling  
(Picture courtesy of Energy Inform)*

Condensation from under-heating will always occur first on the coldest surfaces e.g. single glazed windows and in poorly ventilated places e.g. behind wardrobes. In severe cases, whole walls and ceilings can be affected. This condensation leads to the saturation of wall and ceiling finishes, which can in turn lead to mould growth.
